# Dumaresq Dam Safety

## Background

Armidale Dumaresq Council situated in the Northern Tablelands owns and is responsible for three prescribed dams. These are Dumaresq, Puddledock and Malpas Dams. The oldest of the three Dumaresq Dam, a concrete gravity dam, was constructed in 1896. It was followed in 1928 by Puddledock Dam a concrete arch with concrete gravity abutments. Finally in 1968 Malpas Dam, 31m high earth and rockfill embankment dam located on the Gara River north east of Armidale, replaced Dumaresq and Puddledock Dams as the main water supply for Armidale. Since then Dumaresq Dam, situated some 10 kilometres northwest of Armidale on Dumaresq Creek, has become an important recreational area and is no longer required as a source of raw water for Armidale.

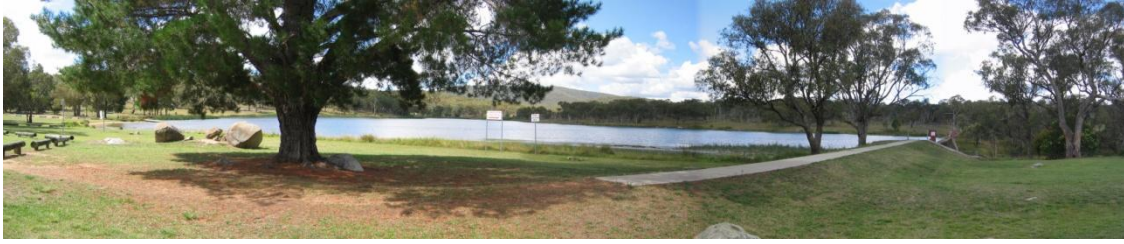
As stated, Dumaresq Dam is a straight concrete gravity dam with a maximum height of 11.9 metres. The length of the crest is 189 metres and width of the crest is 0.8 metres. The right abutment is a 49 metres long homogeneous earthfill embankment with a clay puddle core cutoff down to rock foundation. The embankment is protected by a concrete wing wall whilst on the left the abutment abuts against the natural ground surface.

The spillway slot in the central area of the dam was formed by the construction of 0.75 metre high concrete wall on either side and is at an elevation of 1074.00 m AHD. Any flood with a height above 1074.75 m AHD will utilise the whole of the length of the crest as a spillway. At this stage the freeboard available, i.e. up to the earthfill embankment crest, is 0.55 metres. The capacity of the spillway is 114 m<sup>3</sup>/sec at dam crest level and 300 m<sup>3</sup>/sec at embankment crest level. After flowing over the spillway the kinetic energy of the water is dissipated on the downstream natural rock structure. The embankment crest level, crucial when considering the possibility of the dam failing by over topping, is 1075.30 m AHD.

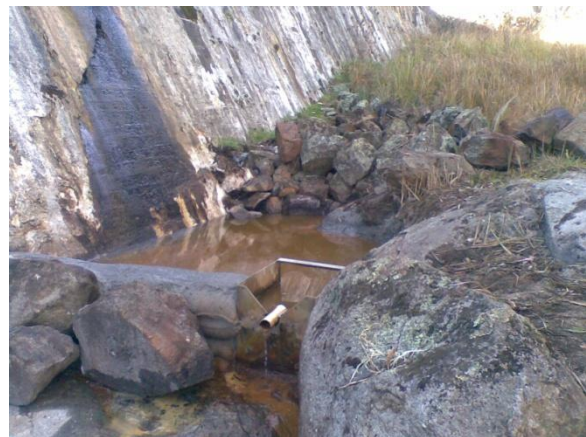
As required by ANCOLD guidelines Dumaresq Dam is inspected three times a week by ADC operational personnel, who have all completed the DSC's three day dam inspection accreditation course. As part of that inspection they measure the seepage through the dam wall. This varies between 0.5 to 1.5 l/min, with the main determinant of the amount of seepage being the ambient temperature, i.e. flow increases during cold winters returning to the lower baseline during the summer.
